## CCTV Survey

Customer	MAURICE CANN	Resource	Martin Reilly
Contact	Maurice Cann		
Address	The Larches, Hutton Road Scotton DL9 3RF	Job type	CCTV Drain Survey
		Reference	DC105451
		Date	24/01/2023 12:30 - 16:30
		Job duration	04:00:00
		Driving duration	00:29:51
		Distance travelled	16.8 mi

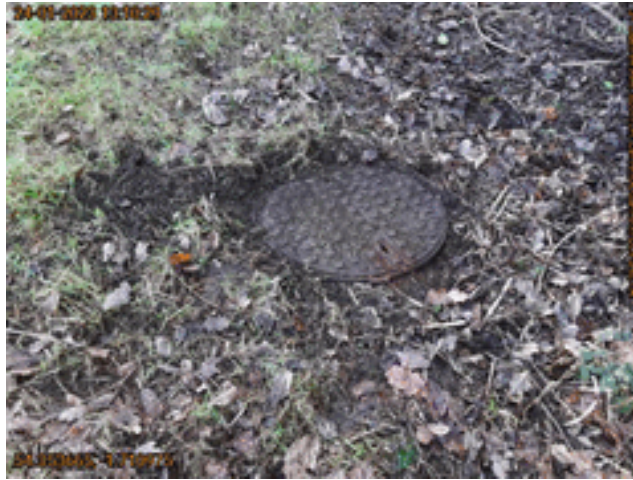
Answer	Notes
On initial inspection how many visible manholes are there?	3 manholes	
Are there any hidden manholes?	No	
Please describe the surface eg. patio, grass, concrete	Concrete and grass

Take photo of each manhole (internal and external images if possible). For hidden manholes, take photo of area where manhole is located

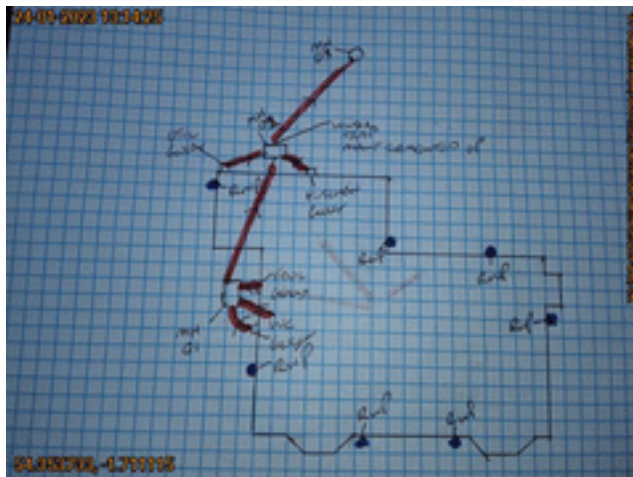
Please upload a copy of your site drawings

From manhole 01 to manhole 02 there is a hole and fractures in the line at one point. Please see CCTV footage.

Yes the line from manhole 02 fo manhole 03 because manhole 02 has a Windsor trap and the maintenance point has been cemented up and manhole 03 is seized solid so cant lift it out of the frame.
